07/19/89 United Airlines

Report Number	NTSB/AAR-90/06
Access Number	PB90-910406
Report Title	United Airlines Flight 232, McDonnell Douglas DC-10-10, Sioux Gateway Airport, Sioux City, Iowa, July 19, 1989
Report Date	November 1, 1990
Organization Name	National Transportation Safety Board Office of Aviation Safety Washington, D.C. 20594
WUN	5158D
Sponsor Name	NATIONAL TRANSPORTATION SAFETY BOARD Washington, D.C. 20594
Report Type	Aircraft Accident Report July 19, 1989
Distribution Status	This document is available to the public through the National Technical Information Service, Springfield, Virginia 22161
Report Class	UNCLASSIFIED
Pg Class	UNCLASSIFIED
Pages	126
Abstract	<p>This report explains the crash of a United Airlines McDonnell Douglas DC-10-10 in Sioux City, Iowa, on July 19, 1989. The safety issues discussed in the report are engine fan rotor assembly design, certification, manufacturing, and inspection; maintenance and inspection of engine fan rotor assemblies; hydraulic flight control system design, certification, and protection from uncontained engine debris; cabin safety, including infant restraint systems; and aircraft rescue and firefighting facilities. Safety recomm

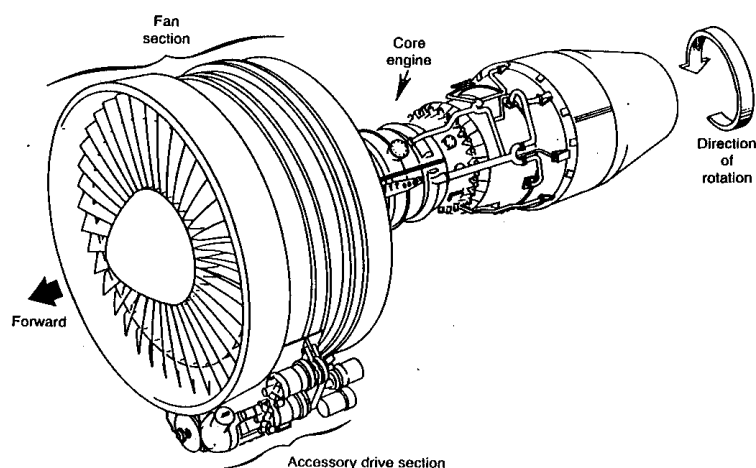
Figure 4.--CF6-6 engine.

Photographs of the airplane were taken by observers on the ground during its final approach to Sioux Gateway Airport. They showed that the No. 2 engine fan cowl and the fuselage tail cone were missing. The remainder of the No. 2 engine appeared intact. Postcrash examination of the wreckage revealed that the No. 2 engine fan rotor components forward of the fan forward shaft, as well as part of the shaft, had separated from the engine in flight. (See [figure 3](#), [figure 4](#), [figure 5](#)).

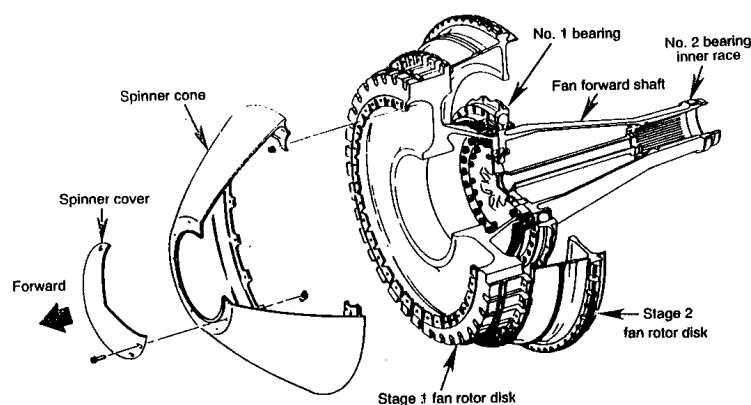
Figure 5.--CF6-6 fan rotor assembly.

Figure 16 shows a drawing of a CF6-6 engine fan rotor assembly, most of which departed the No. 2 engine of the accident airplane inflight. The assembly consists of the large stage 1 disk and attached fan blades and retainers, the smaller stage 2 disk and attached blades, the spinner cone and cover, and various mounting and balancing hardware. A cutaway view of the engine in the area of the stage 1 disk is shown in [figure 17](#).

The stage 1 fan disk weighs 370 pounds and is a machined titanium alloy forging about 32 inches in diameter. GEAE convention refers to various portions of the disk as the rim, the bore, the web, and the disk arm, as labeled in [figure 17](#). The rim is about 5 inches thick and is the outboard portion of the disk. The rim contains the axial "dovetail" slots, which retain the fan blades. Also, the stage 2 fan disk is bolted to the aft face of the rim. The bore is about 3 inches thick and is the enlarged portion of the disk adjacent to the 11-inch-diameter center hole. Extending between the rim and bore is the disk web, which is about 0.75 inch thick. The conical disk arm extends aft from the web at a diameter of about 16 inches. The conical arm diameter decreases in the aft direction to about 10 inches at the disk arm flange where the disk bolts to the fan forward shaft (also labeled [in figure 17](#)).

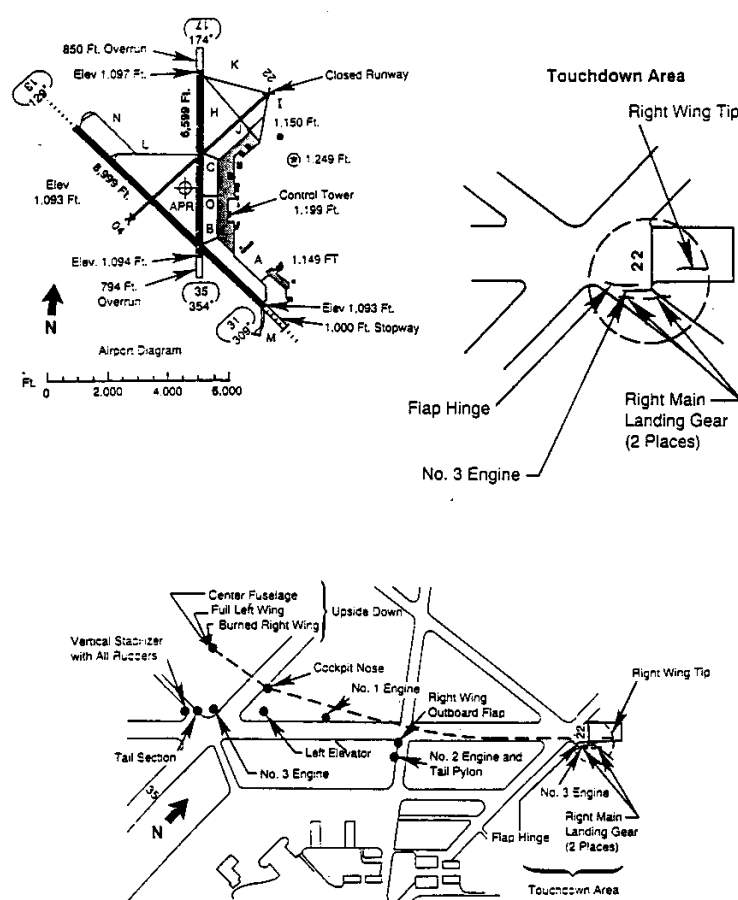
Figure 6.--Sioux Gateway Airport and wreckage path of UA flight 232.

The cockpit separated early in the sequence and came to rest at the edge of runway 17/35. The largely intact tail section continued down runway 22 and came to rest on taxiway "L." The engines separated during the breakup. The No. 1 and No. 3 engines came to rest near taxiway "L" and the intersection of runway 17/35, between 3,000 and 3,500 feet from the point of first impact. (See [figure 6](#).)

The No. 2 engine came to rest on taxiway "J" to the left of runway 22, about 1,850 feet from the point of first impact. The majority of the No. 2 engine fan module was not found at the airport.

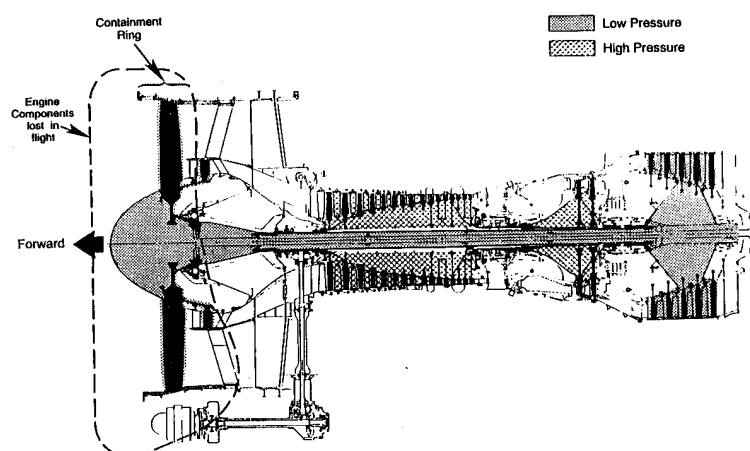
Figure 8.--CF6-6 rotating assemblies.

Figure 7 contains a cutaway sectional drawing of the flow path and construction of the CF6-6 engine. The figure also shows the fan and accessory drive sections. Figure 8 displays the CF6-6 rotating assemblies. The portion of the No. 2 engine that departed the airplane is outlined by the dashed lines.

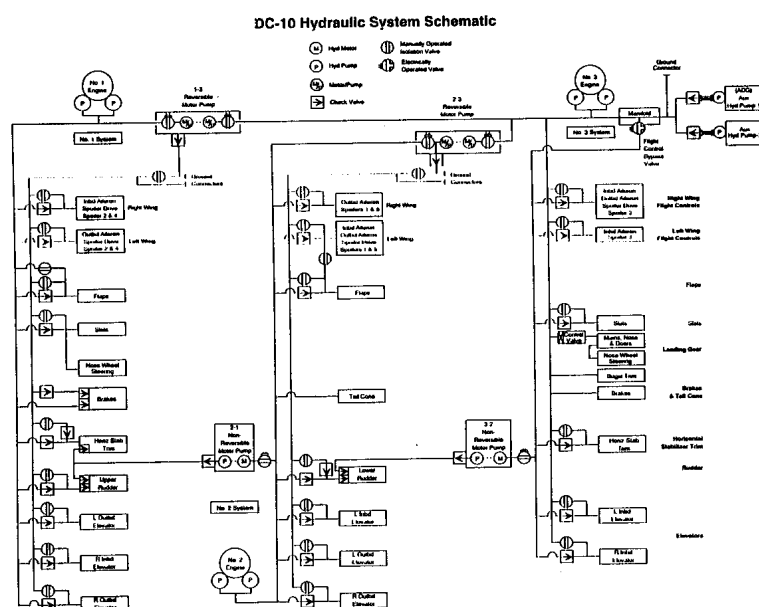
Figure 10.--DC-10 hydraulic system schematic.

The No. 1 hydraulic system provides power to the right inboard aileron and the left outboard aileron, the right inboard and outboard elevators, the left outboard elevator, the upper rudder, the horizontal stabilizer trim, and the captain's brake system. The No. 2 hydraulic system provides power to the right outboard aileron and the left inboard aileron, the inboard and outboard elevators on the left side, the outboard elevator on the right side, and the lower rudder. It also provides power to the isolated closed-loop system that operates the upper rudder. The No. 3 hydraulic system provides power to the right inboard and outboard aileron and the left inboard aileron, the inboard elevators on the right and left side, horizontal stabilizer trim, and the first officer's brake system. It also drives an isolated closed-loop system that powers the lower rudder actuator. These closed-loop arrangements allow for operation of the remaining parts of hydraulic systems No. 2 and No. 3 in the event of damage to the rudder hydraulic system. [\(See figure 10\).](#)

The hydraulic components and piping are physically separated to minimize the vulnerability of the airplane to multiple hydraulic system failures in the event of structural damage. The No. 1 hydraulic system lines run along the left side of the fuselage to the rear of the airplane and along the front spar of the horizontal stabilizer and the vertical stabilizer. The No. 2 hydraulic system lines are routed from the center engine along the rear spar of the horizontal and vertical stabilizers. The No. 3 hydraulic system lines run along the right side of the fuselage to the tail area and along the rear spar of the horizontal stabilizer. The No. 2 hydraulic system lines are not routed forward of the rear wing spar, in order to isolate them from wing engine fragmentation, and No. 3 hydraulic system lines in the tail section are not routed aft of the inboard elevator actuators in order to minimize exposure to possible engine fragmentation damage from the tail-mounted engine.

The DC-10-10 hydraulic system was designed by the manufacturer and demonstrated to the FAA to comply with 14 CFR 25.901, which in part specified that, "no single [powerplant] failure or malfunction or probable combination of failures will jeopardize the safe operation of the airplane...."

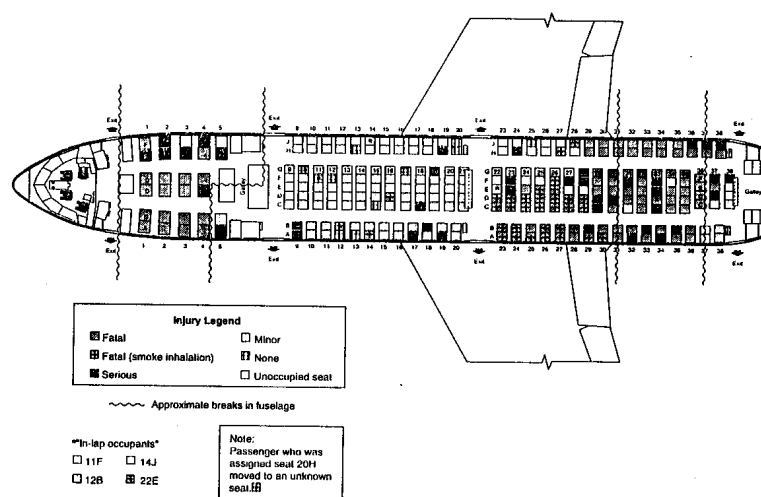
Figure 15.--Seating and injury information.

Of the 296 persons aboard the airplane, 110 passengers and 1 flight attendant were fatally injured. Autopsies revealed that 35 passengers died of asphyxia due to smoke inhalation, including 24 without traumatic blunt force injuries. The other fatally injured occupants died of multiple injuries from blunt force impact. Of the remaining 185 persons onboard, 47 sustained serious injuries, 125 sustained minor injuries, and 13 were not injured. [\(See figure 15\).](#)

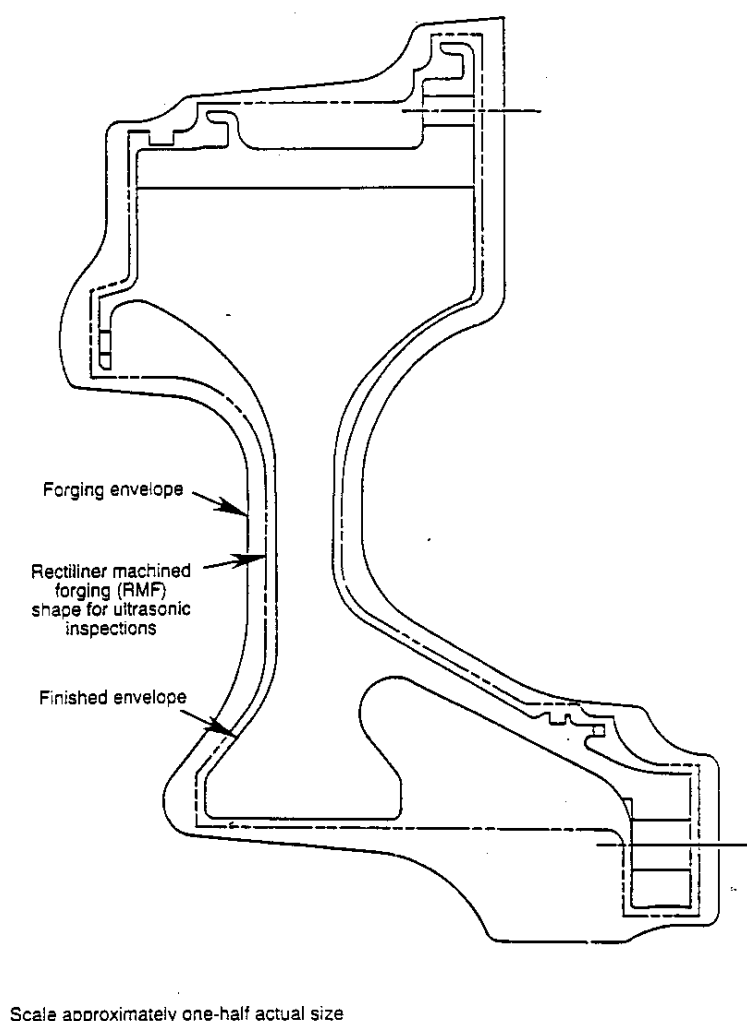
Figure 20.--CF6-6 stage 1 fan disk envelopes at various stages of manufacture.

During the records search for the manufacturing routing package of stage 1 fan disk S/N MPO 00385, it was learned that two rough machined forgings⁹ (referred to as disk "A" and "B") having this same serial number had been routed through GEAE manufacturing. Actual receiving documentation at GEAE could not be located. Figure 20 depicts the three shapes of the disk during the manufacturing process.

Inspection Site	GE	CONAM
Date on Insp. Record	6/23/71	1/31/72
U/S Indication		
Dist. From Aft Flg.	4 inches	4 inches
Clock Pos. from S/N	11:30 o'clock	11:30 o'clock
Depth	2-3/4 inches	3-1/4 to 3-7/16 inches
Circumf. Length	3/8 inch	3/16 inch
Signal strength (at 12 dB)	50% of max.	60% of max.
Angle, radial shear	20°	25°

CONAM shipping records showed that disk "A" was returned to GEAE-Evendale on January 31, 1972. It remained at GEAE and was reportedly scrapped and cut up for examination on November 1, 1972. Records of sectioning and microscopic examination of the ultrasonic indication disclosed only macrostructural features in the area of the indication. No evidence of a hard alpha inclusion, or other defect was found. There is no record of any warranty claim by GEAE for defective material and no record of any credit for GEAE processed by ALCOA or TIMET.

Before disk "A" was shipped to CONAM, a manufacturing process record, called a Dispatch Order (DO), indicated that a disk S/N MPO 00385 (disk "B") was machined into a rectilinear machined forging shape on September 13, 1971, and that this disk passed immersion ultrasonic and macroetch inspections on September 29, and 31, 1971.

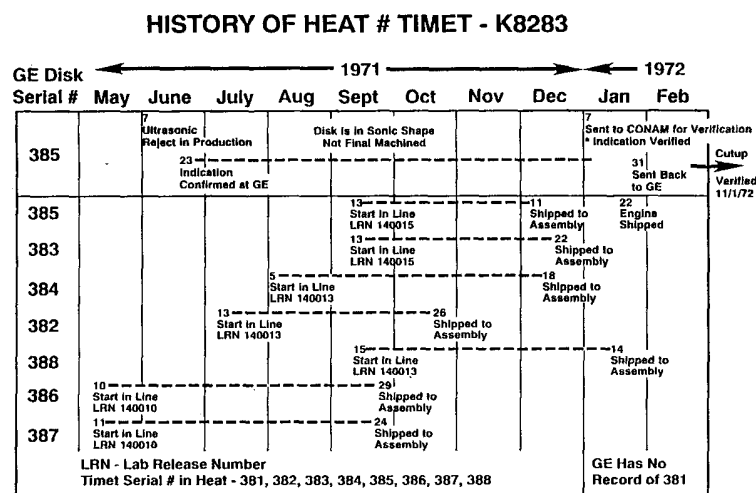
Figure 21.--Calendar history of manufacturing activity of heat K8283 prepared by GEAE.

The calendar history of the GEAE manufacturing activity for the eight forgings reported by ALCOA as comprising heat K8283 is shown in tabular summary. (See figure 21). Although ALCOA records indicate that a forging S/N AJV 00381 was produced from TIMET heat K8283, no record of this forging or disk could be found at GEAE.
